Manhole Inspection Summary

Manhole # S49G__002MH

Insp Date: **9/16/08 2:34 PM**

Location Address: **patterson park**

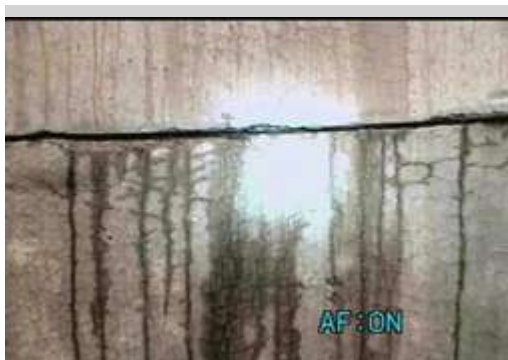
Miscellaneous

Infiltration: ☐ None ☒ **Joint** ☐ Cracks ☐ Mortar ☐ Roots ☐ Wall

closeup of corbel infiltration

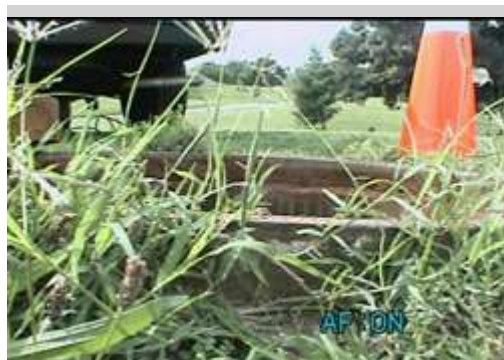
Miscellaneous

above grade

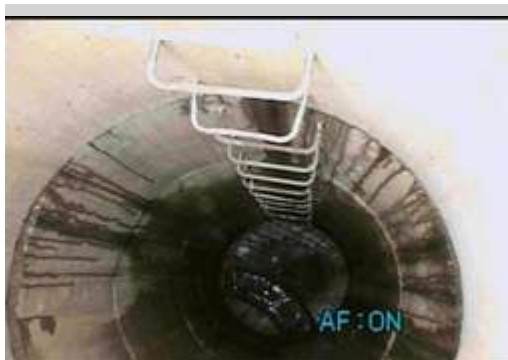
Defect 3

Steps Count: **16** Missing: **0** ☒ **Corroded**

corroded steps, corbel joint infiltration

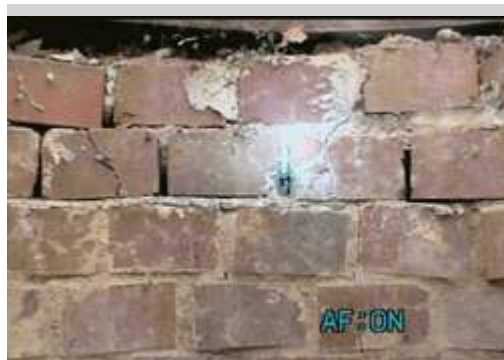
Defect 2

Condition: ☐ Sound ☒ **Cracked** ☐ Root Intrusion ☒ **Loose Brick** ☒ **Deteriorated**

chimney cracked, loose bricks, deteriorated frame adj

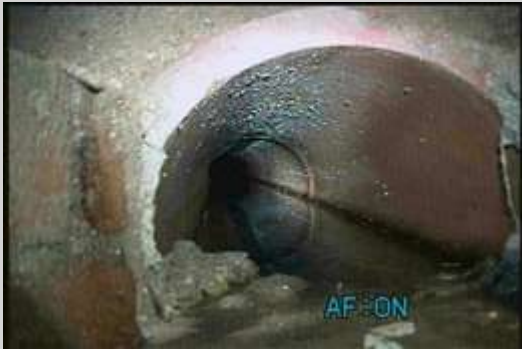
12 O'Clock Outflow

10 in. Circular Gravity Sewer
Pipe Out @ 12 O'Clock

Pipe Material: **Clay** ☐ Pipe Lined

Invert Depth: **19.58** (ft.) Flow Characteristics: **Slow**

Infiltration: **None** Pipe Seal Cond: **Unknown**

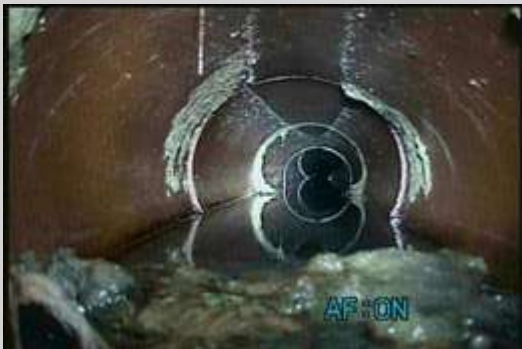
7 O'Clock Inflow

10 in. Circular Gravity Sewer
Pipe In @ 7 O'Clock

Pipe Material: **Clay** ☐ Pipe Lined

Invert Depth: **19.33** (ft.) Flow Characteristics: **Slow**

Infiltration: **None** Pipe Seal Cond: **Unknown**
